Docket No. 217 – Development and Management Plan Inspection

Date: November 10, 2005

Location: Norwalk Substation Expansion

Location: Plumtree Substation Expansion, Bethel

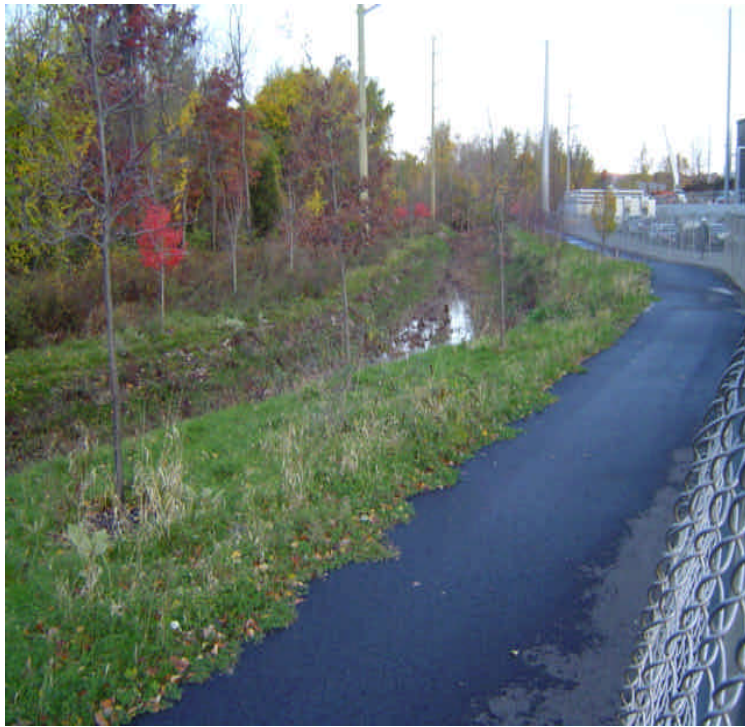
Norwalk Substation: Photo on the left shows a view of the overflow channel following the rains. Photo on the right shows the turning structure area which has been regraded. 11/10/05

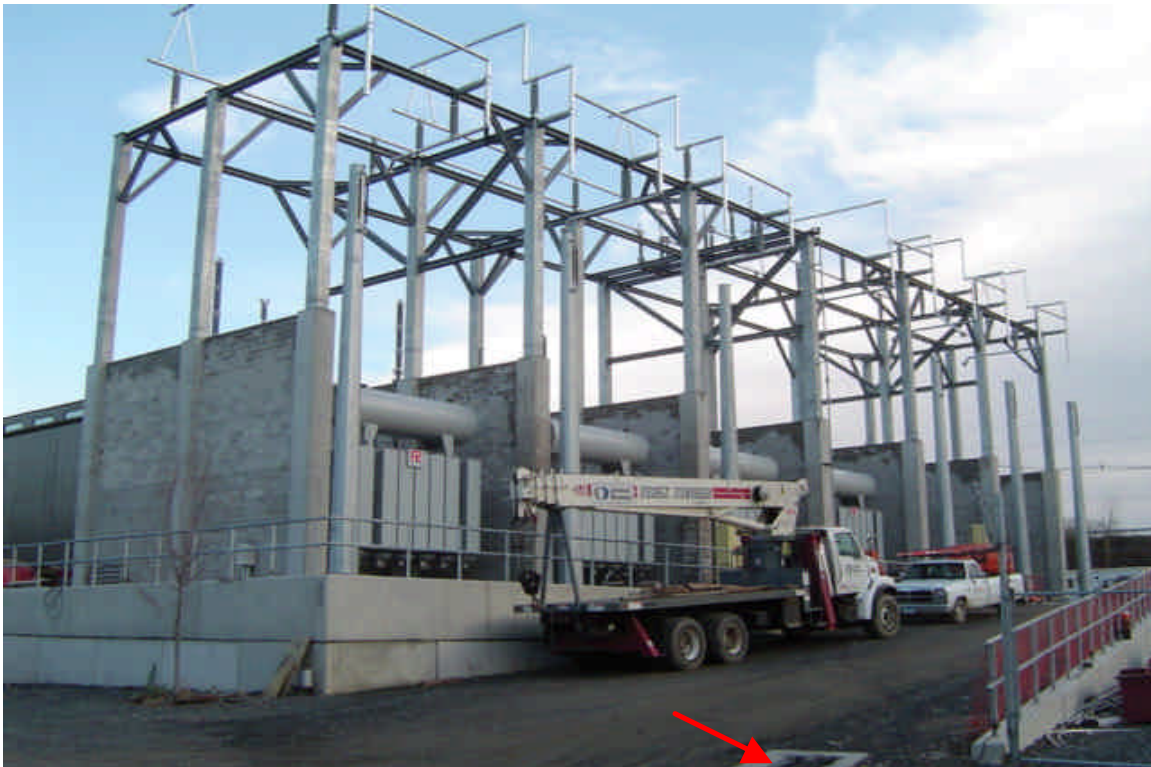
Areas of Inspection	Observation	Recommended Action
Erosion and Sediment Controls (includes inspection within 24 hours of a storm event)	<ul style="list-style-type: none"> - A catch basin at the southern corner of the GIS building has sediment accumulating either on the fabric within the grate or within the basin itself. 10/27/05-11/10/05. - Sedimentation from the access road off the Rt. 7 ramp was noted in the vegetated perimeter swale but it did not leave the site. 9/21/05-11/10/05. -The overflow channel had some accumulated sediment at the edge of the river due to the flooding and potentially the adjacent fill work. 10/27/05-11/10/05. - The work at the turning structure is now completed and some bare soil remains in the area. . 11/10/05. - Silt fence was noted along the bike path while work took place to set the footings. 11/10/05 	<ul style="list-style-type: none"> - Clear the fabric of sediment and replace protective/control measures. If the sediment has reached inside the basin, clean out any buildup. 10/27/05-11/10/05. - Sedimentation and gravel remain contained within the swale. The access road will be paved eventually which will remove the problem. Continue to monitor area until final stabilization. 9/21/05-11/10/05. - Sediment may need to be removed by hand here in order to restore the original capacity of the channel. 10/27/05-11/10/05. - It should be confirmed the channel is at original grades and the disturbed surfaces should be mulched at least as re-vegetation will not occur at this time. 11/10/05. - None at this time. 11/10/05

View of the GIS building and transformer area. The catch basin indicated appears to be either filling with sediment or the fabric here needs to be replaced. 11/10/05.

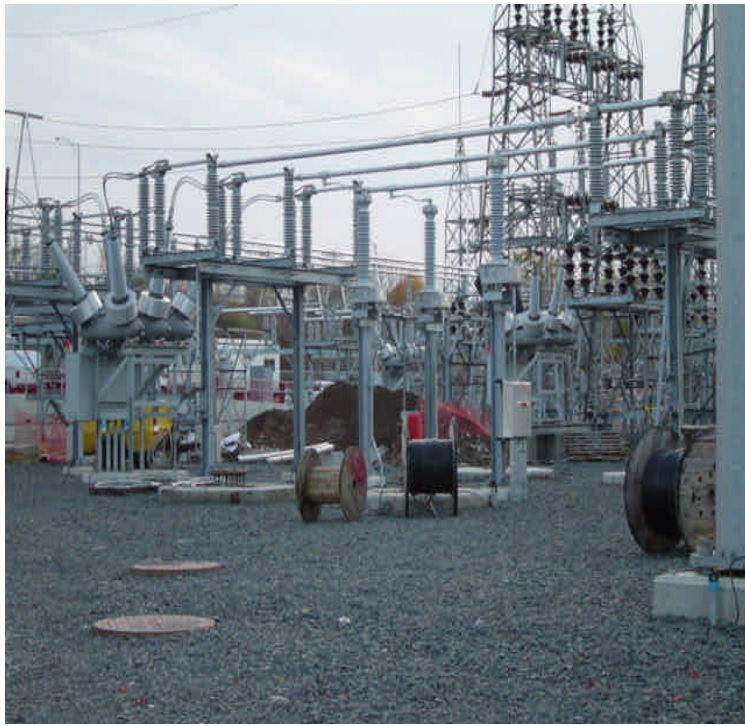
Photo on the left shows activity within the yard. Photo on the right shows footings being placed at the northwest side of the site. Silt fence is in place along the bike path. 11/10/05

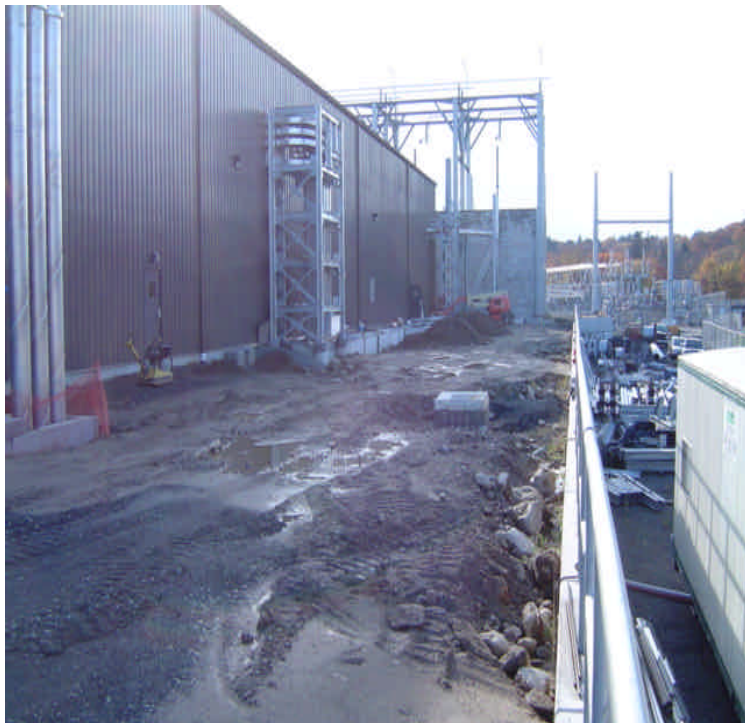
Photo on the left shows a drainage structure installed on the west side of the GIS building. Photo on the right shows Plumtree Substation where most work is complete at this time. 11/10/05
